SMOKE, FIRE AND FUMES IN TRANSPORT AIRCRAFT

PAST HISTORY, CURRENT RISKS AND RECOMMENDED MITIGATIONS

Part 2: Training

A Specialist Paper by the **Royal Aeronautical Society**

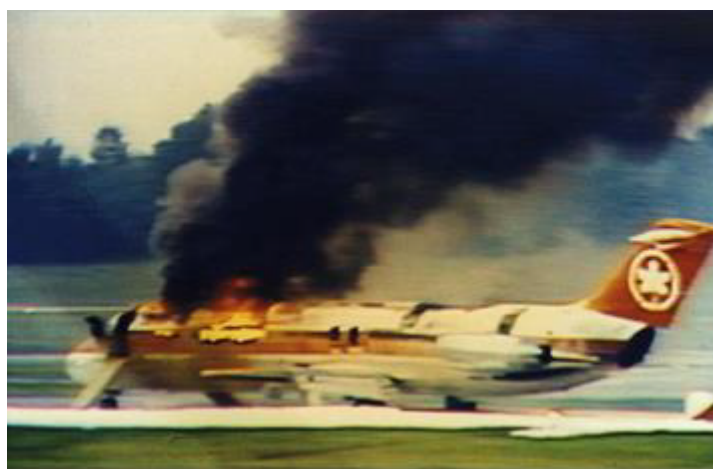
DC-9 accident – Cincinnati June 1983

In Advisory Circular (AC) 120-80A – In-flight Fires (FAA, 2014), the FAA identified that the time for the situation to become non-survivable was as little as seven minutes, and that only in one third of hidden fire events would the aircraft reach an aerodrome before the fire became uncontrollable. An example of this is the accident involving an Air Canada DC-9 which diverted to Cincinnati in June 1983 when a lavatory compartment fire became uncontrollable (NTSB, 1986).

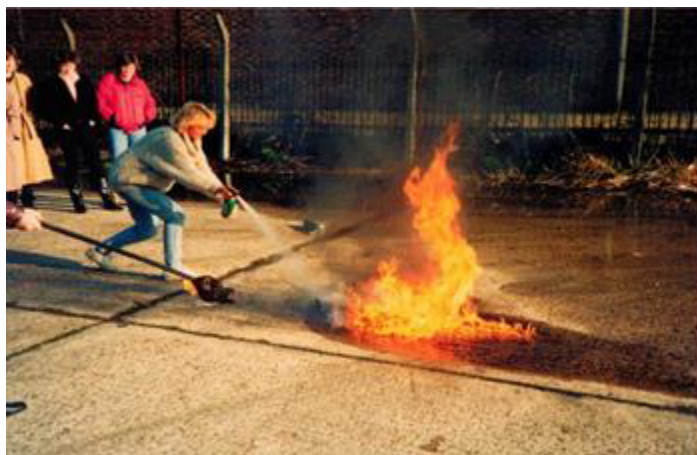
During training in the 1980s, aircraft crew usually fought fairly large fires in the open air. At that time oil tray fires were favoured and Halon could be used. These fires were usually quite large and challenging. They could be difficult to extinguish unless the correct procedure was used, such as aiming the extinguisher at the base of the flames. Re-ignition was often a major factor. While a fire of such size would be most unlikely to occur on a commercial aircraft, it did provide an awareness of the problem and also the effectiveness of Halon.

Practical fire training in the 1980s
